## FUEL SYSTEM/CARBURETION

### Fuel Tank Assembly - 500 Models

1997 Xplorer 500, Sportsman 500

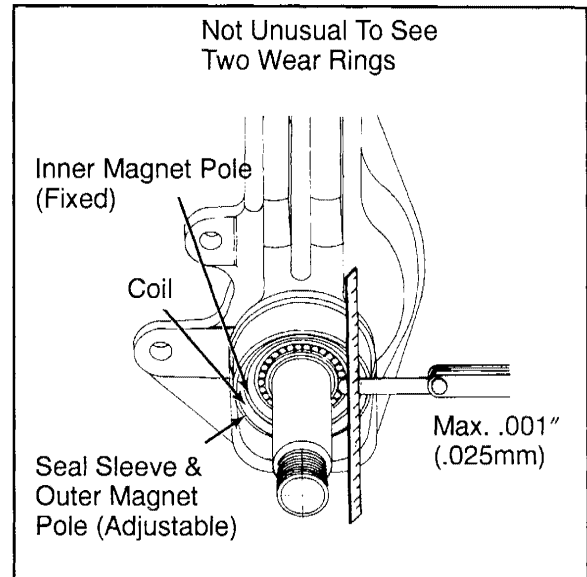
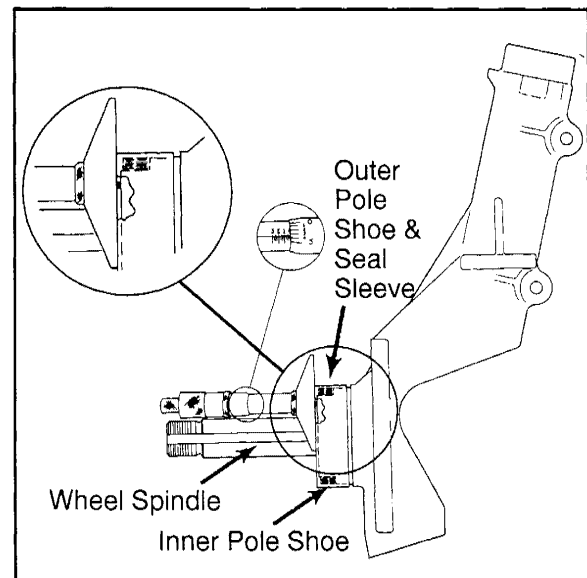
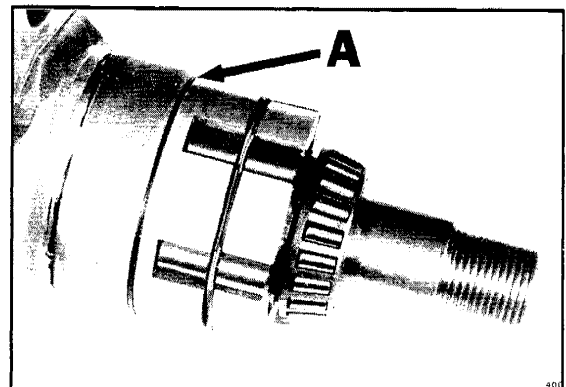
### Seal Sleeve Replacement, Cont.

5. To check the gap between the inner and outer poles place a straight edge on the outer pole so that it just intersects with the inner pole. The gap between the straight edge and inner pole should be 0 to .001" (0-.025mm). This measurement should be checked in three different positions around the pole assemblies. The three measurements must be within .0005" (.013 mm) of each other. If the gap is excessive, the hub may not engage.

6. The outer magnet pole (seal sleeve) is adjustable by either tapping inward or placing a small punch to the inside edges and tapping the outer pole (sleeve) outward.

**Pole Gap:**  
.000"-.001" (.00-.025mm)

7. Install the roller clutch assembly and be sure the armature plate (A) is positioned properly. Also, when installing the hub assembly, be sure the armature plate tabs remain engaged with the roller clutch cage.
